**RME-ENVESS22M868LOR-01/A (01)**

## MECHANICAL TEST REPORT

1 box equipped with: BGL136-NAV2:& CALT25 & CAL4/100IG

**LOREME SA**

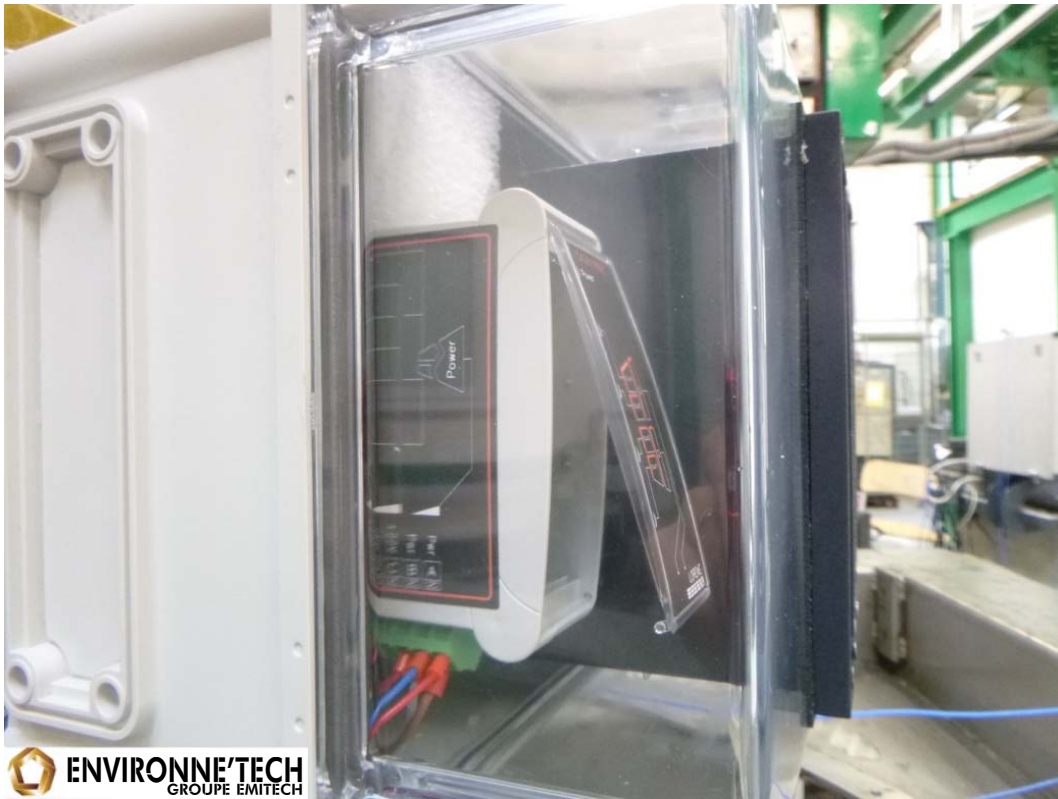
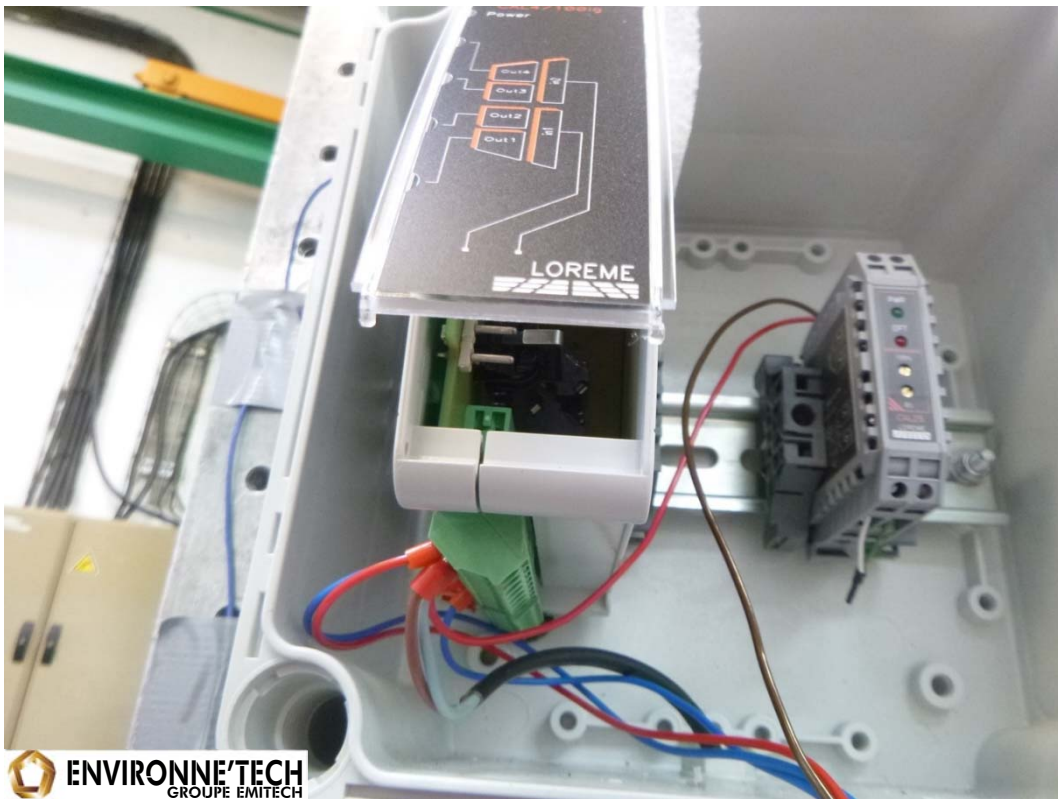
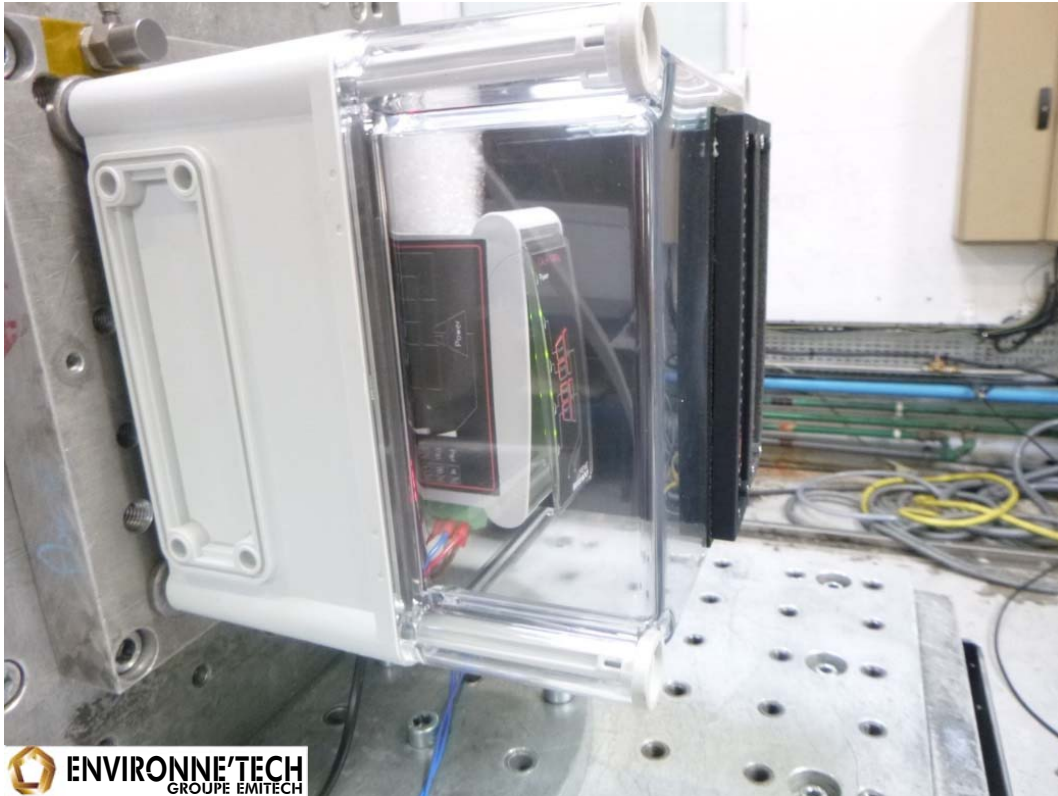
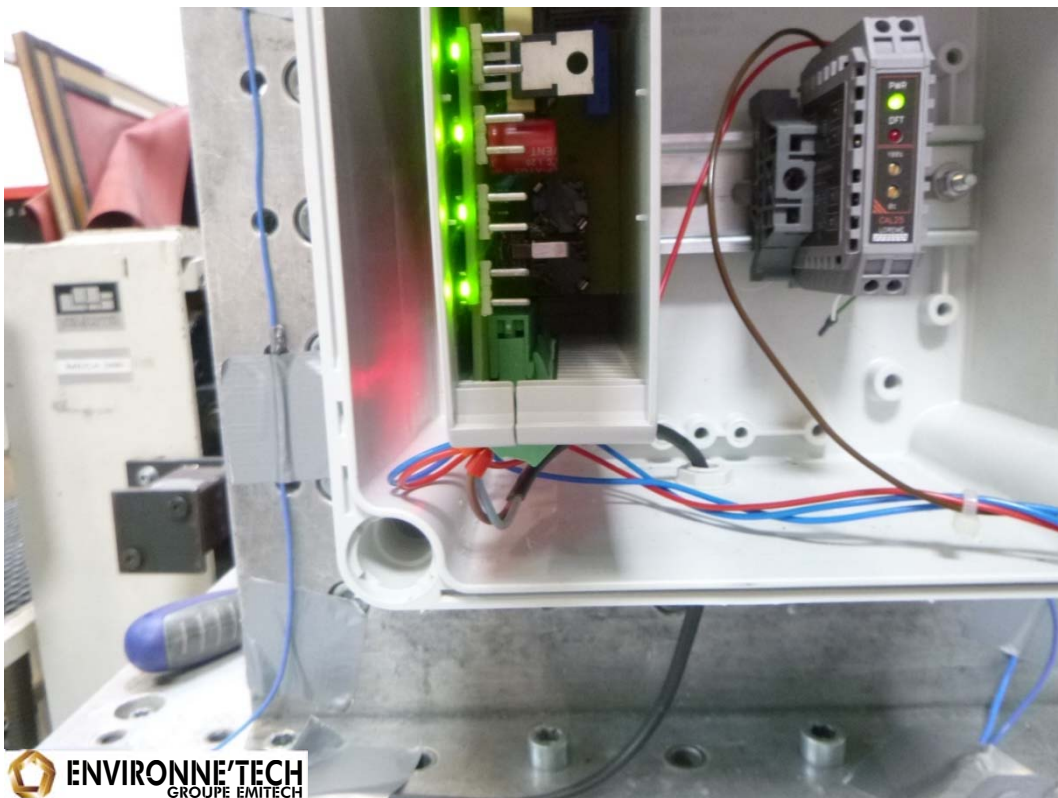
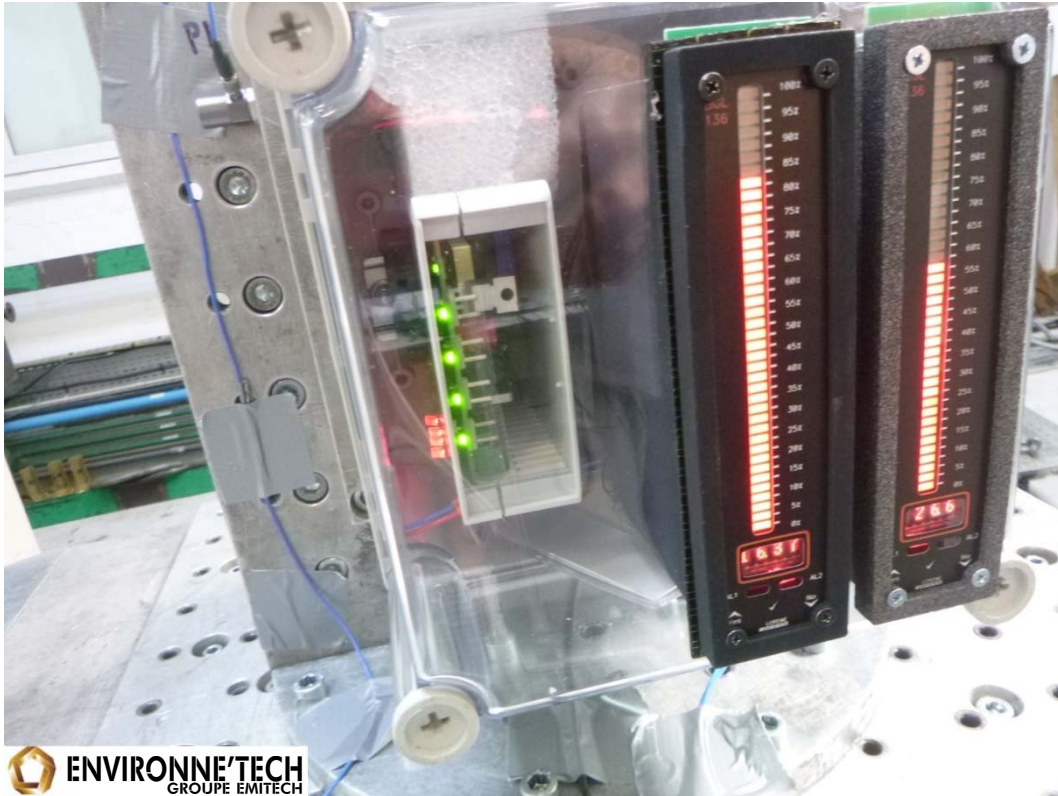
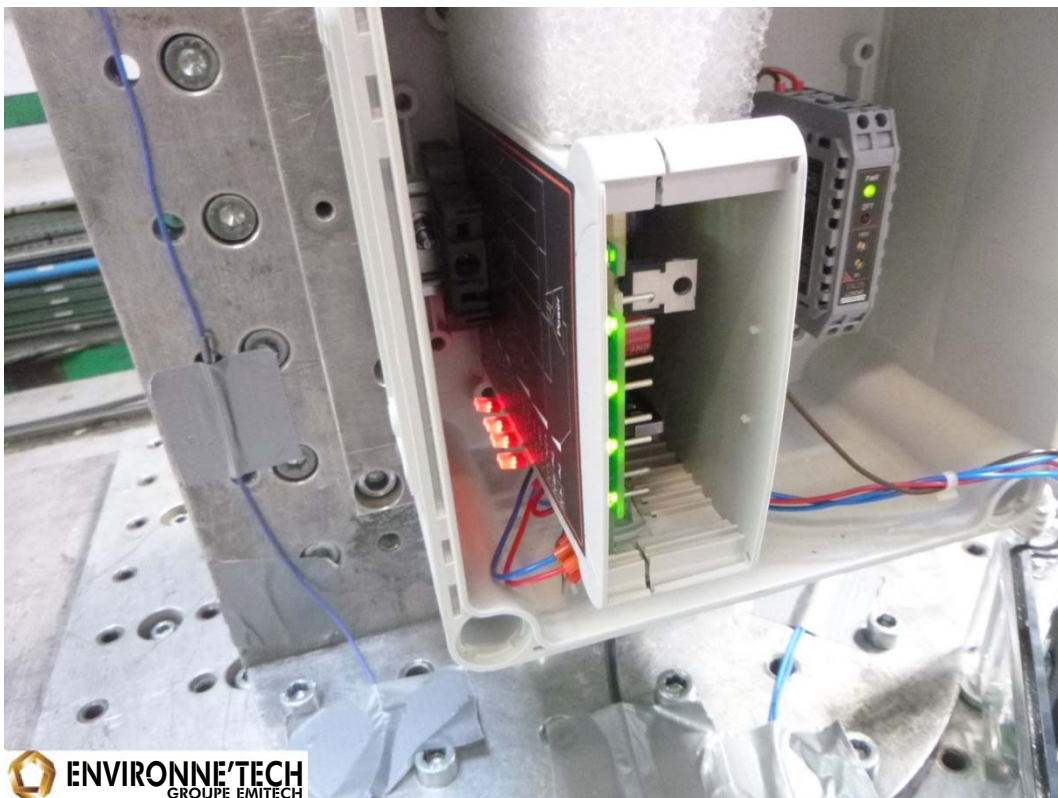
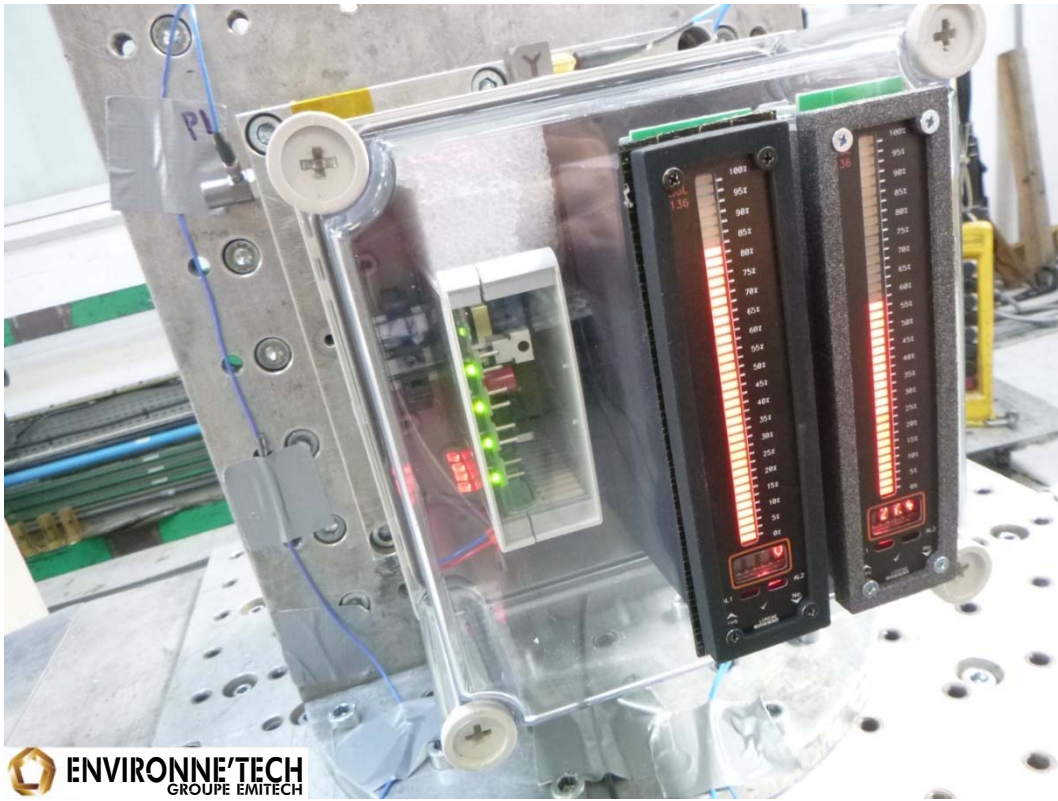
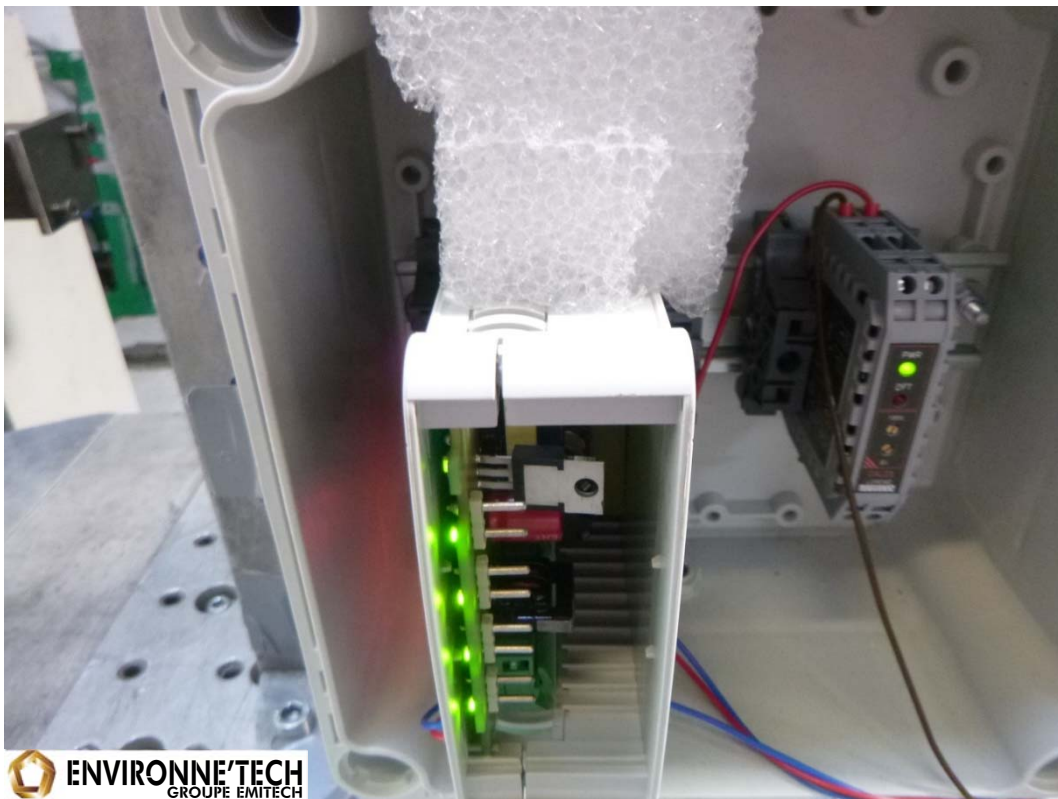
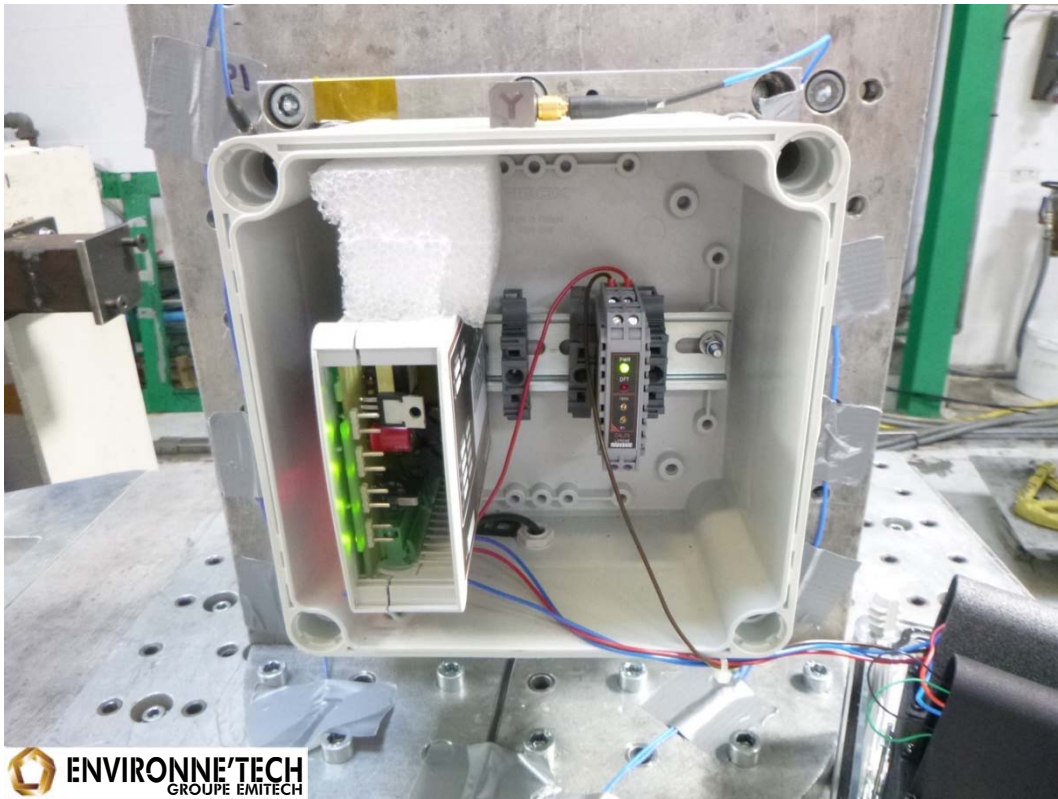
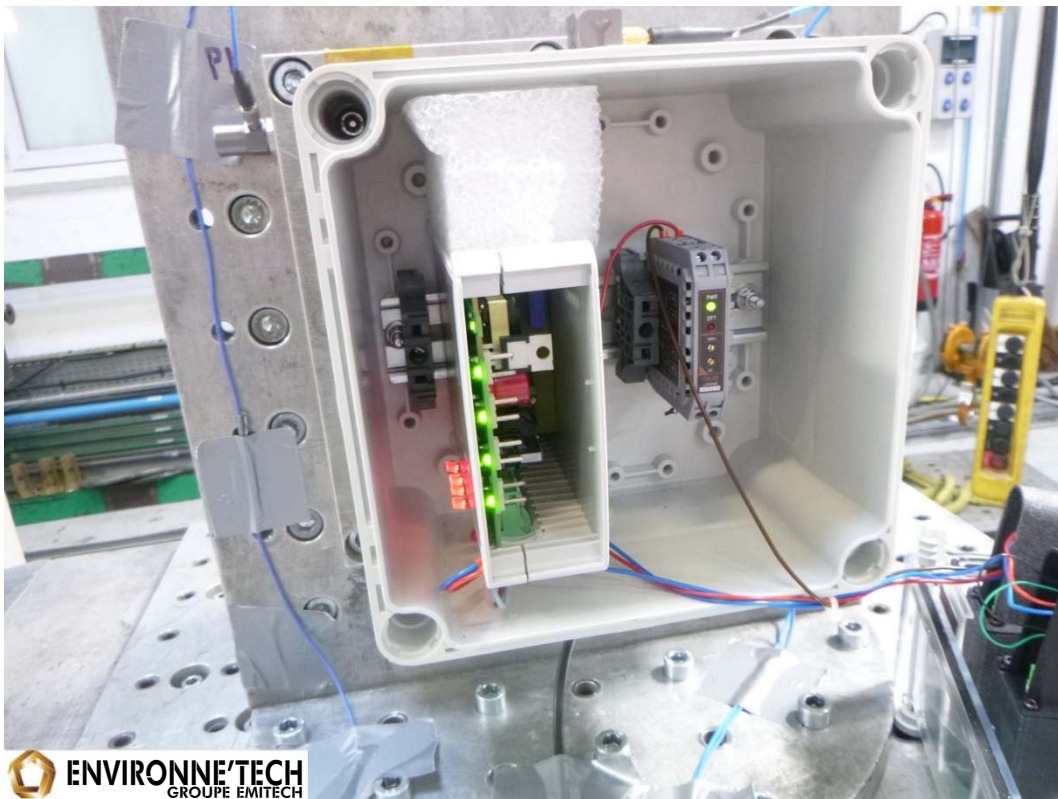
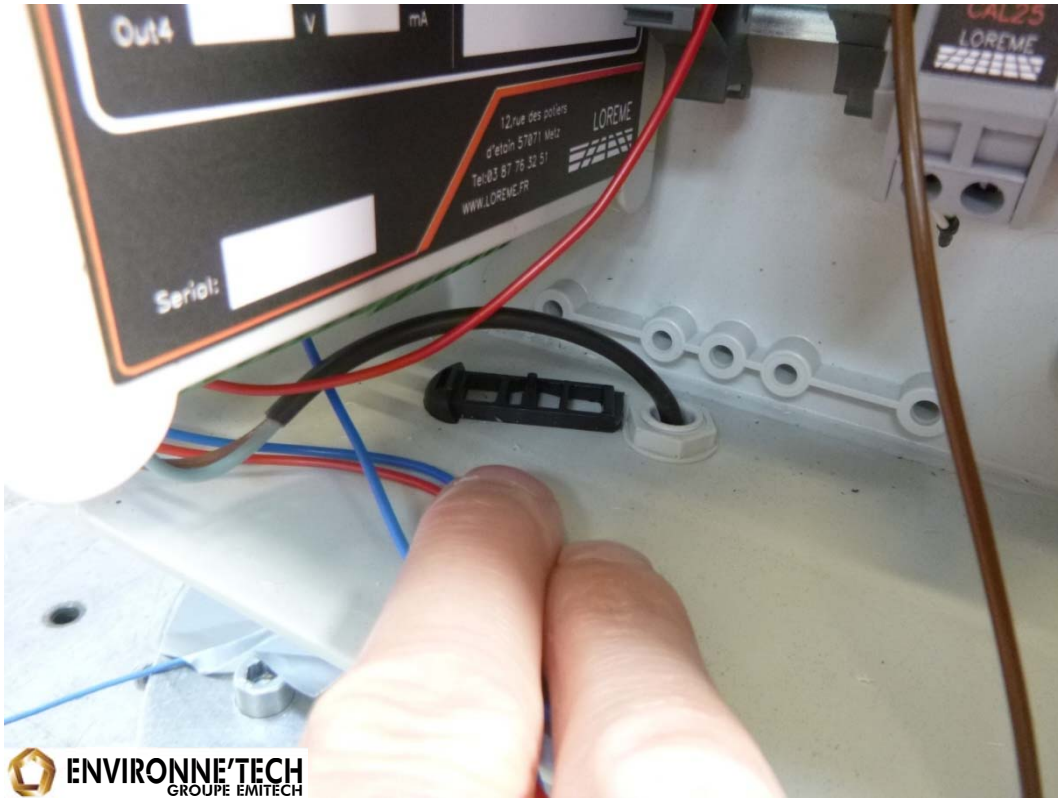
<b>Shock tests</b>	<b>Visuals observations</b>	<b>Photos*</b>	<b>Functional test</b>
Z+	/	/	OK
Z-	The lid of CAL4/100IG opened during the shocks. The CAL4/100IG opens slightly in two parts.	14 15	OK
X+	/	/	OK
X-	The lid of CAL4/100IG opened during the shocks. The CAL4/100IG opens slightly in two parts.	16 17	OK
Y+	The lid of CAL4/100IG ripped off during the shocks. The CAL4/100IG opens in two parts.	18 19	OK
Y-	The lid of CAL4/100IG ripped off during the shocks. The CAL4/100IG opens in two parts. The CAL4/100IG slides freely on the DIN rail, the stops have moved. A piece fell to the bottom of the box.	20 21 22 23 24	OK
